# Estate of Chemetco, Inc.

Subject: Casual Factors Investigation and Corrective Actions Report  
IEMA Incident 20071413  
Hartford, Madison County, Illinois

**ATTACHMENT A**  
**PHOTOS OF STACKS AFTER SOUTH STACK FELL**

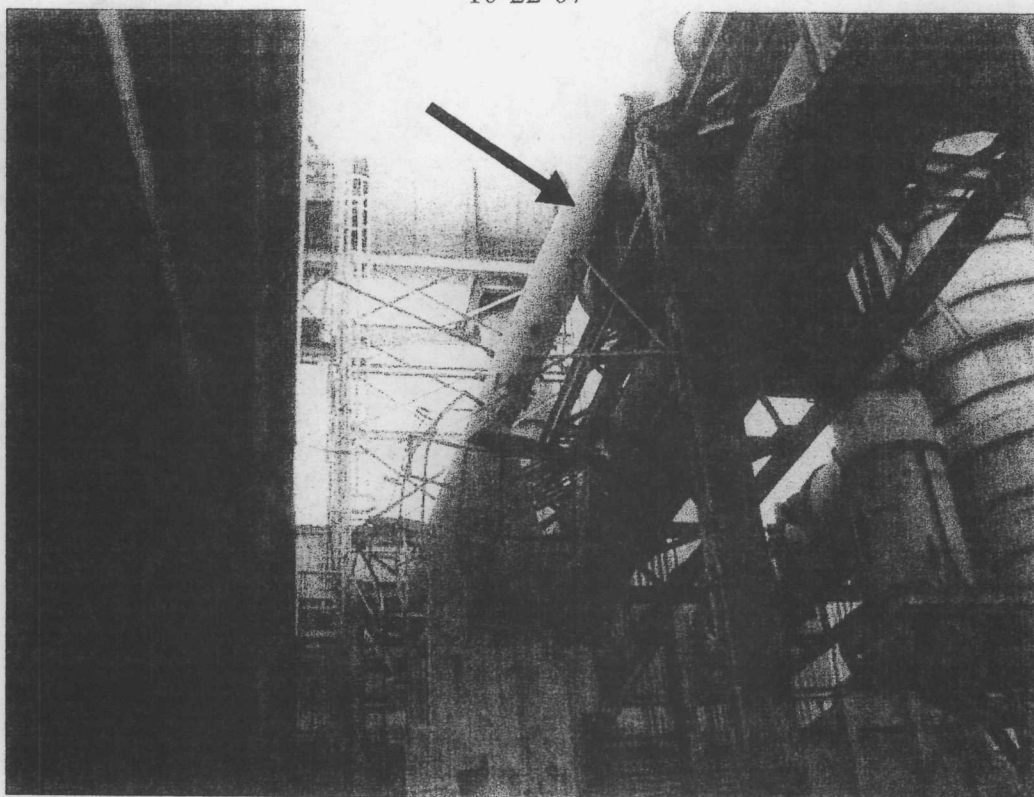
7. The collapsed stack is laying on top of existing ducts in the AAF area in an unsafe manner (Photos # 1, 2, and 3, Attachment A and drawing, Attachment C).

Photo 1 - Looking south at fallen South Stack

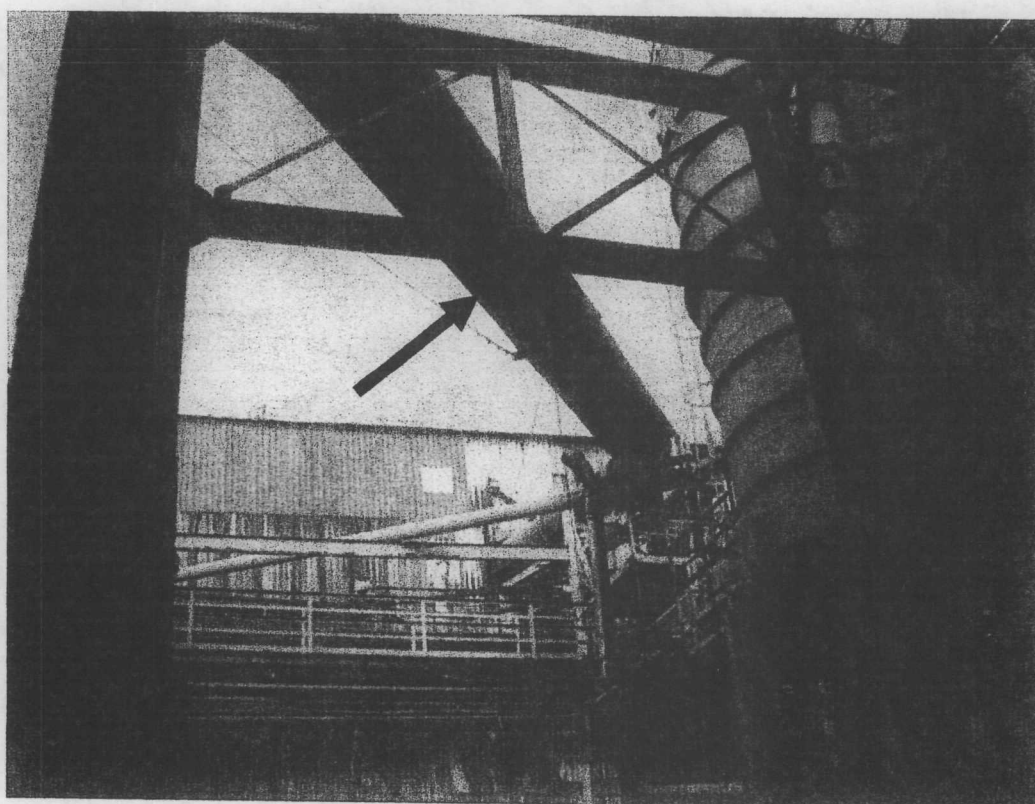
Photo 2 - Looking NW at fallen South Stack across top of AAF System

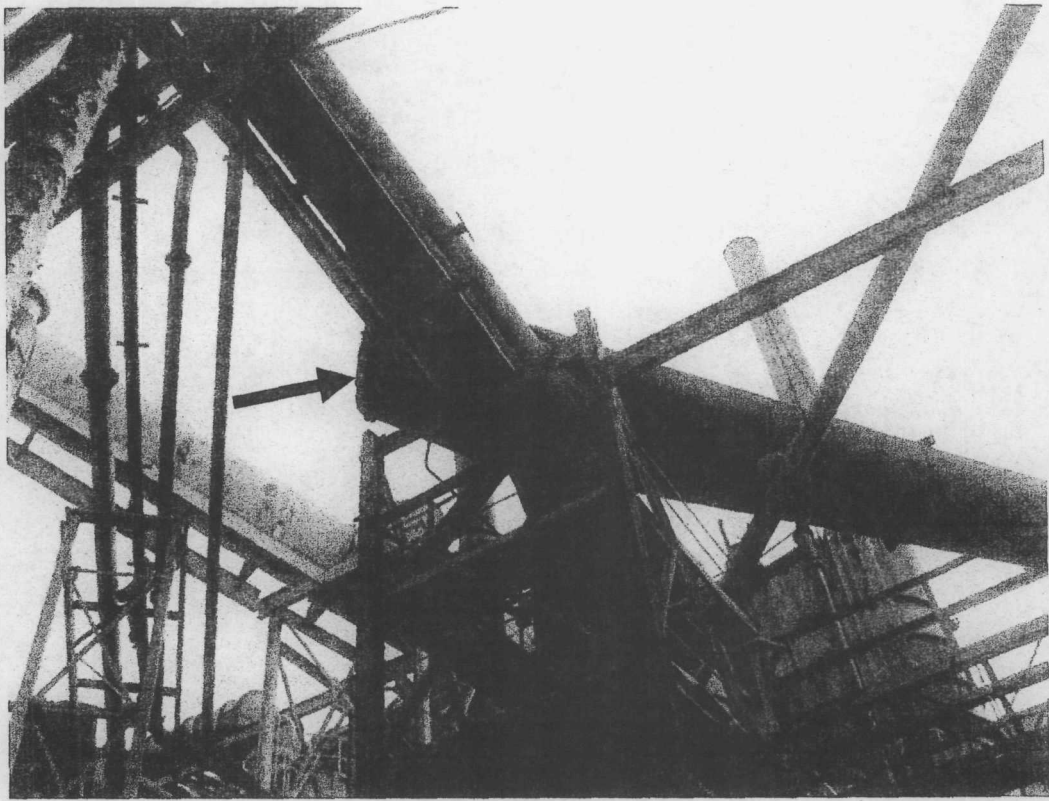
Photo 3 - Looking NE at top of fallen South Stack on top of AAF System duct

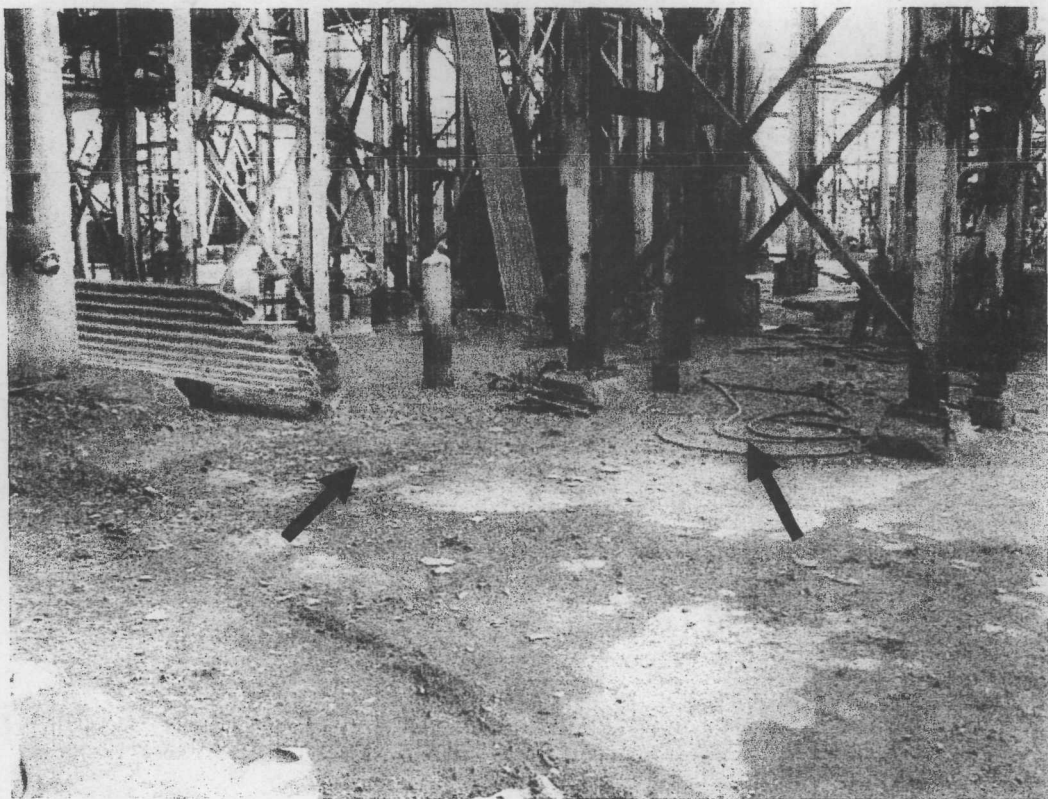
5. Over the weekend of October 20/21, 2007, the South Stack collapsed, resulting in the release of the equivalent of two 55-gallon drums (< 1200 pounds) of a mixture of Scrubber Sludge and iron rust onto over 1/4 inch of pre-existing Scrubber Sludge (Scrubber Sludge that was generated/released during Chemetco's operation of the smelters prior to October 31, 2001.) on the surface of the AAF System (Photos #.4 and 5, Attachment A). The area of release was approximately 20 feet by 20 feet.

Photo 4 - Scrubber Sludge/Iron Scale debris located below top of fallen South Stack

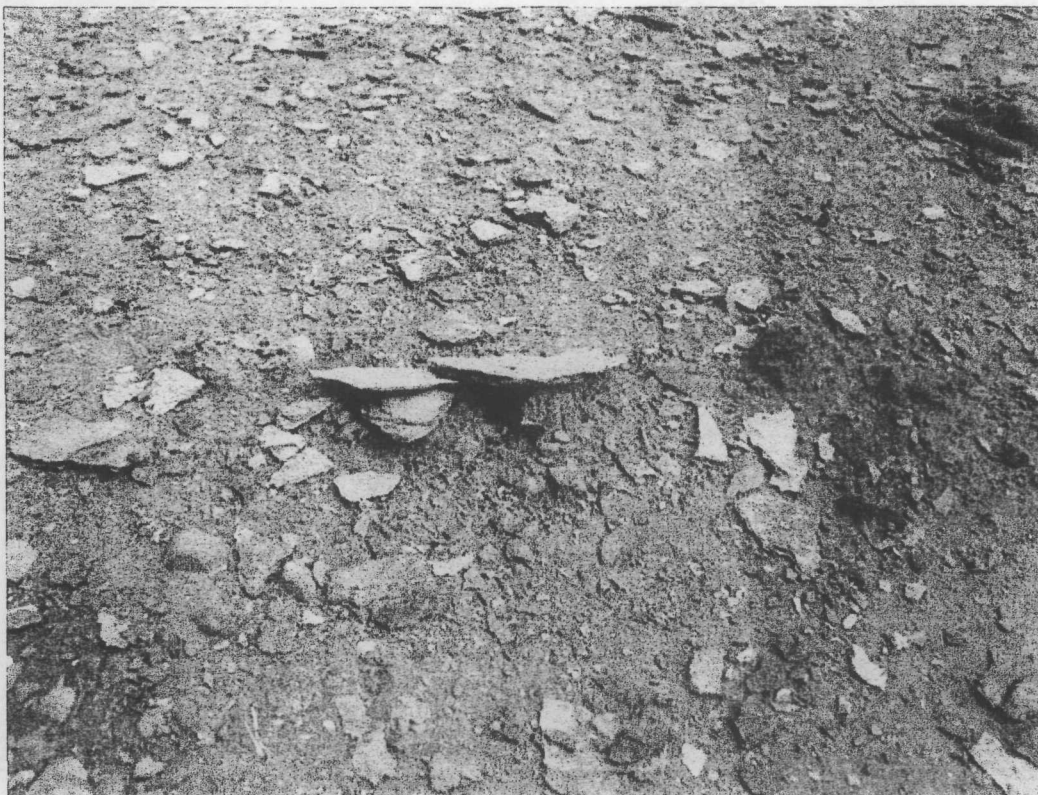
Photo 5 - Closeup of pieces of scrubber sludge/iron scale debris from fallen South Stack

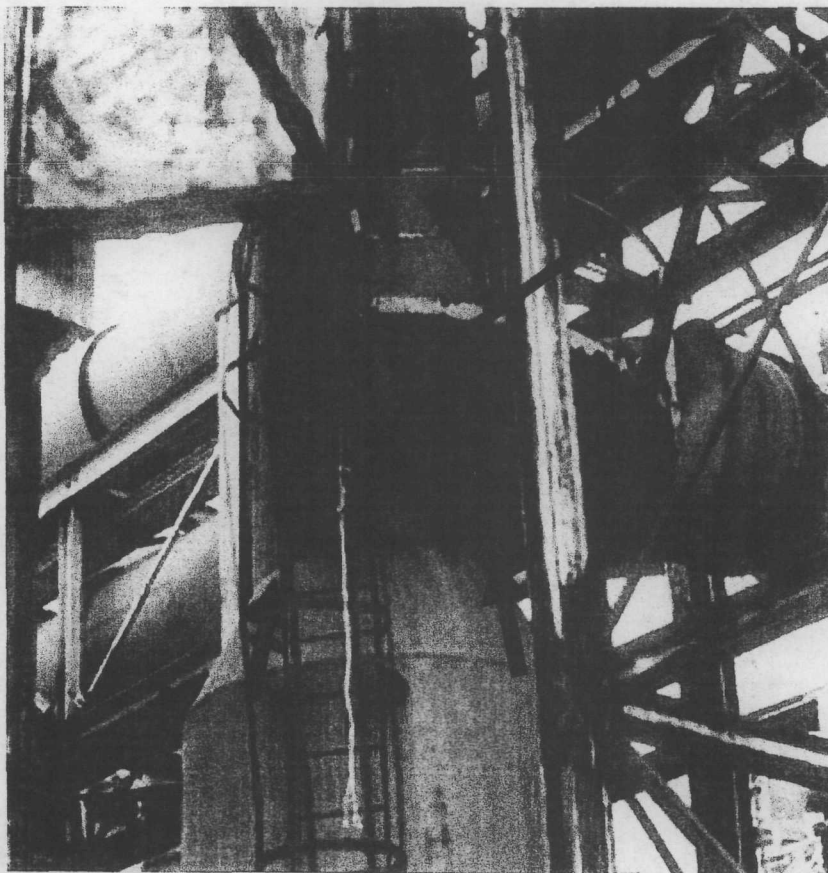
In addition, the weld failure on the Center Stack (Photo # 6, Attachment A and Photos # 1, 2, and 3, Attachment B) between the stack and the base, same area as failure on South Stack, appears to have been damaged by the collapse and is now almost halfway around the stack. The collapse also appears to have made the structural integrity of the other stack worse. The Estate notified the Illinois EPA of the collapse as soon as observed on October 22, 2007, Incident Report No. H2007-1413.

Photo 6 - Expanded metal tear on northeast/north side of Center Stack, probably due to force on this stack by falling South Stack before connecting wire cable pulled loose (same area that failed on South Stack.).

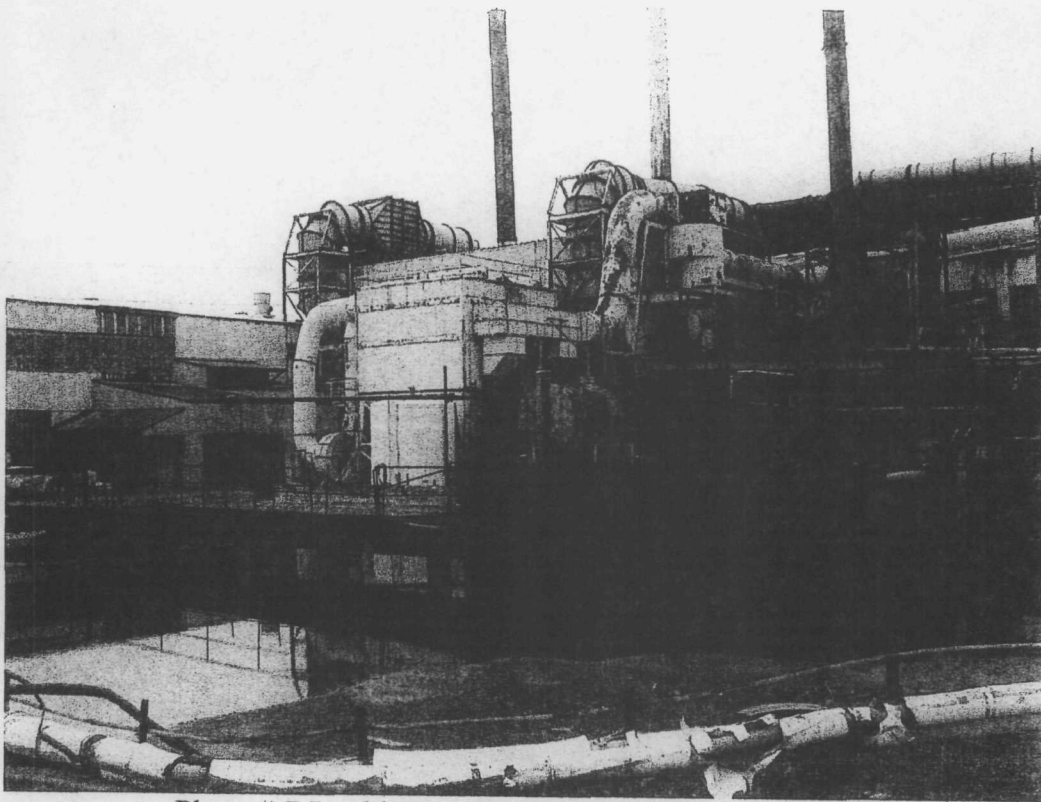
On October 31, 2001, Chemetco, Inc. shutdown and filed for Chapter 7 Bankruptcy on November 13, 2001. Since that date the site (Estate of Chemetco, Inc.) has been under the control of a Trustee. Originally, the Chemetco site had four stacks (drawing, Attachment C). Over thirty years of operations and the corrosive nature of Scrubber Sludge, pH 9-10, have caused the carbon steel stacks to have thin walls which have resulted in numerous stress fractures and weld breaks (photos, Attachments A and B). Even though connected by wire cables, the 120-foot high stacks have been subjected to various wind loadings and weathering and have been a concern to the Estate. In 2005 the northern most stack was removed down to its base using a high boom crane from the north side of the AAF System to prevent collapse and even allowed the Scrubber Sludge/iron rust mixture to be deposited inside the remaining base. The other three stacks were located inside the congested AAF System of exhaust ducts, piping and buildings and not safely accessible (see Photo #7, Attachment A and drawing Attachment C).

Photo # 7-Looking east at stacks in AAF System area

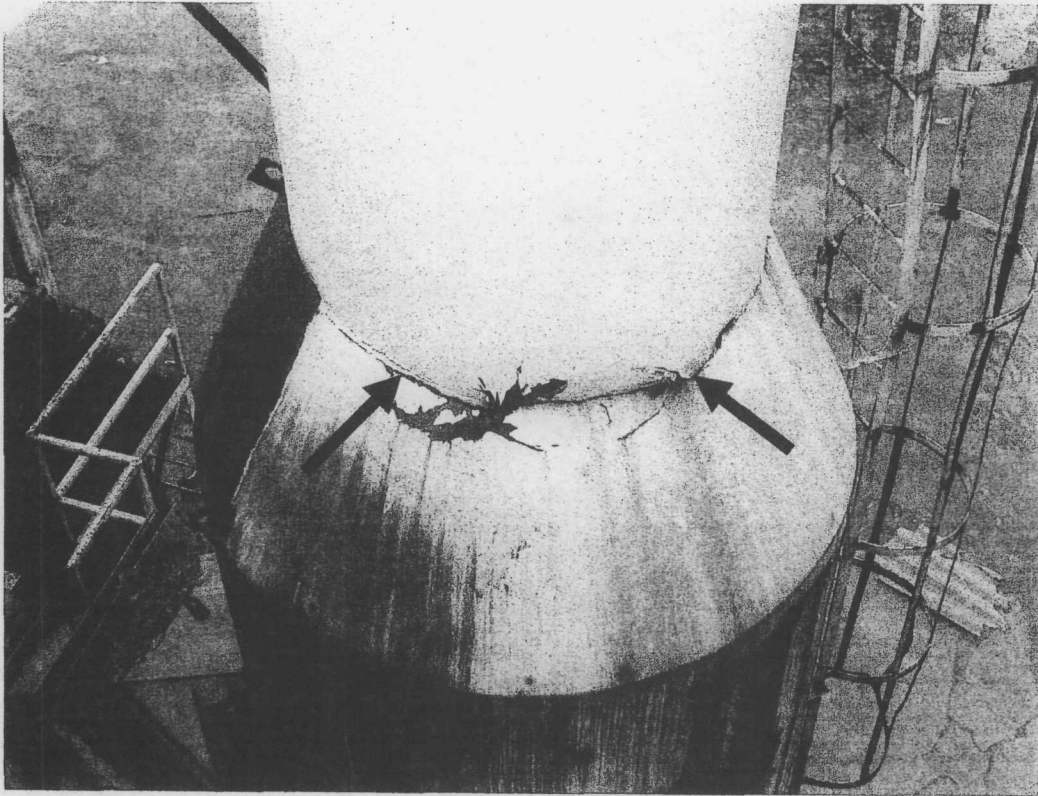
Photo 1 -Looking down from Rotofilter Bldg at South Stack stress failures.

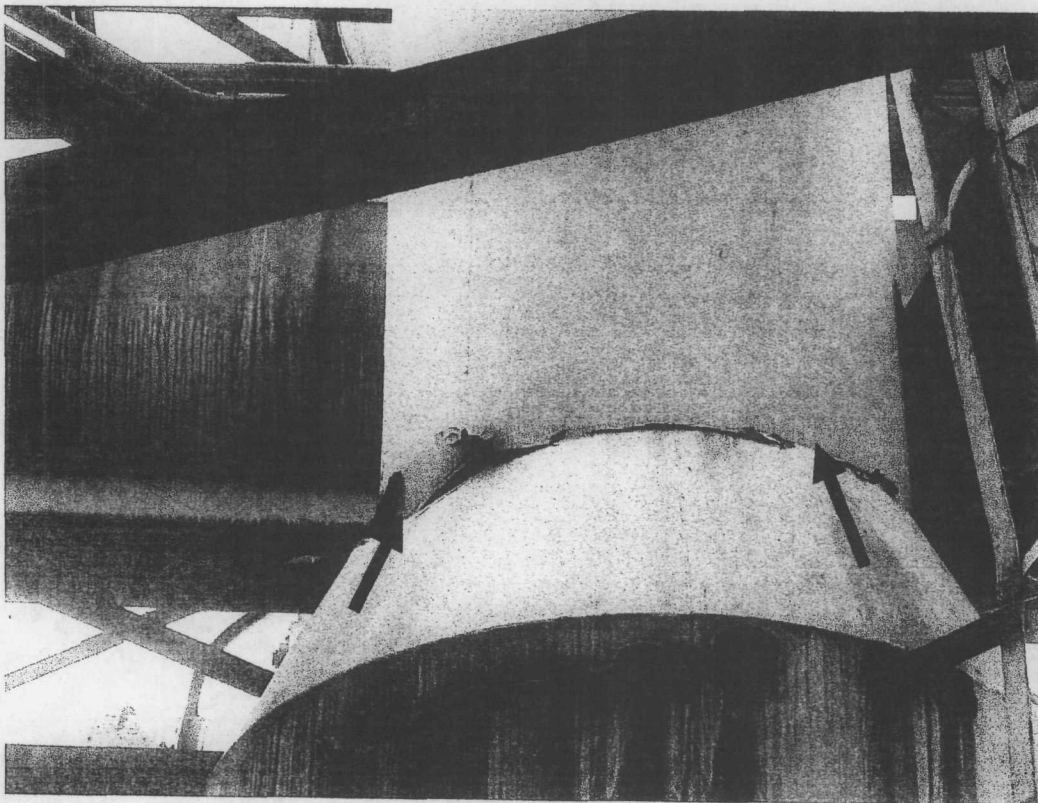
Photo 2 - Looking east at metal failure between stack and base on South Stack

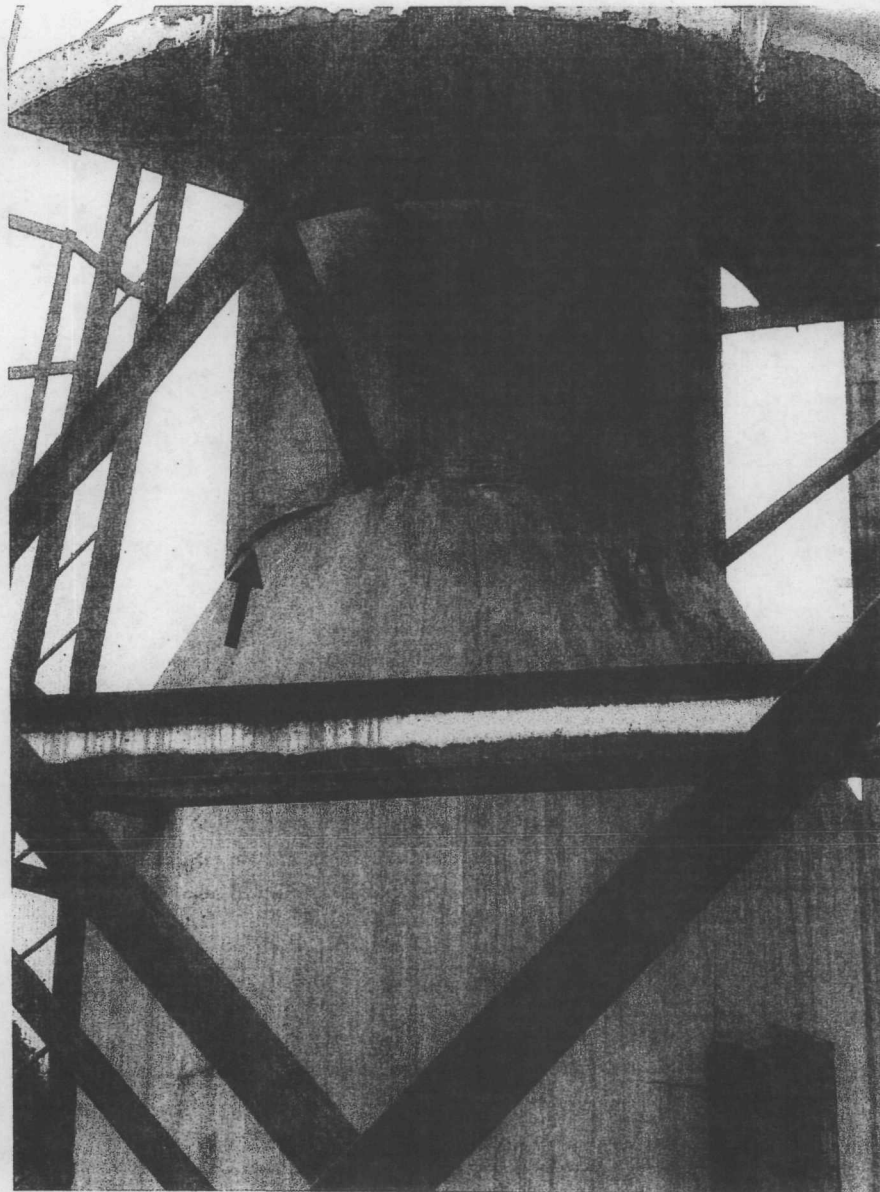
10. The remaining two stacks are in imminent danger of collapsing (Photos # 3 and 4, Attachment B) and IEPA has granted permission to the Estate to perform controlled collapse of this stacks (Attachment F).

Photo 3 - Looking south at metal failure between stack and base on Center Stack

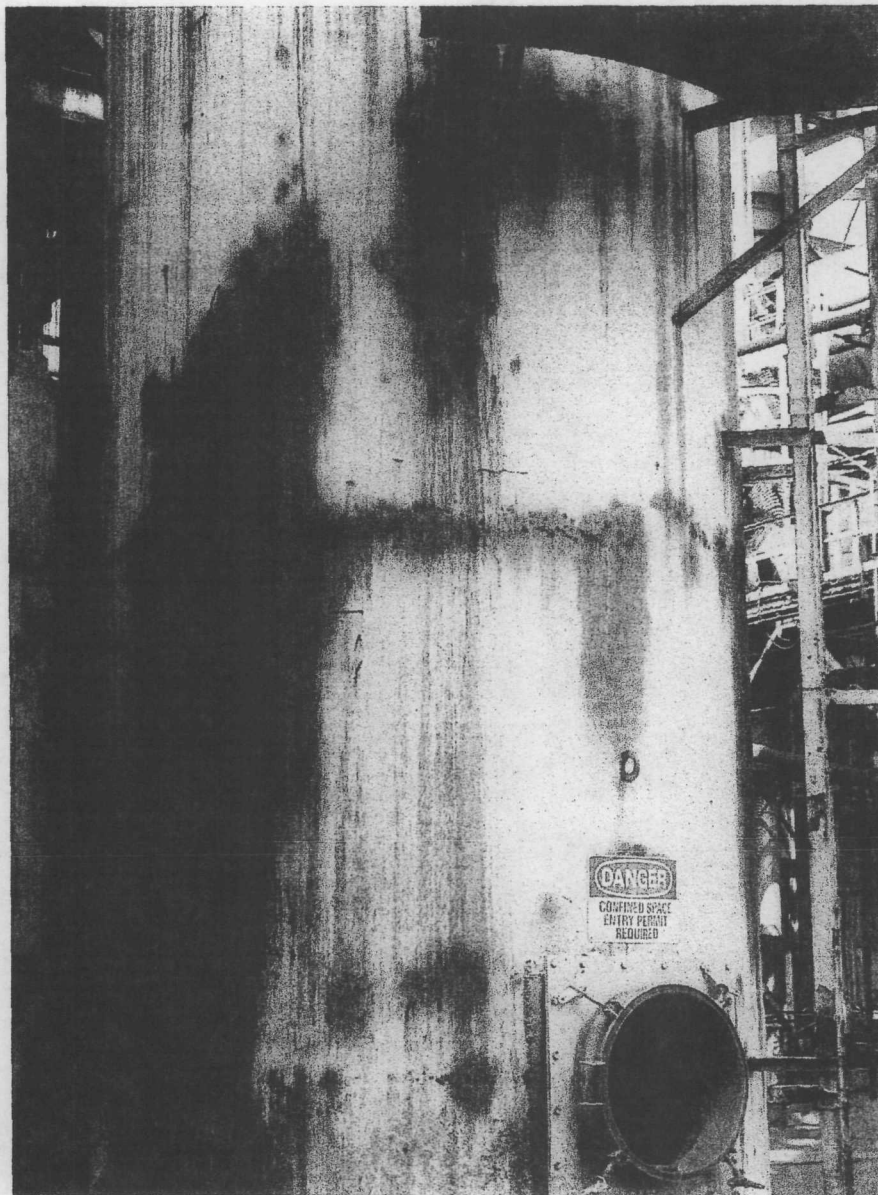
Photo 4 - View of stress and corrosion failures on base of South Stack.

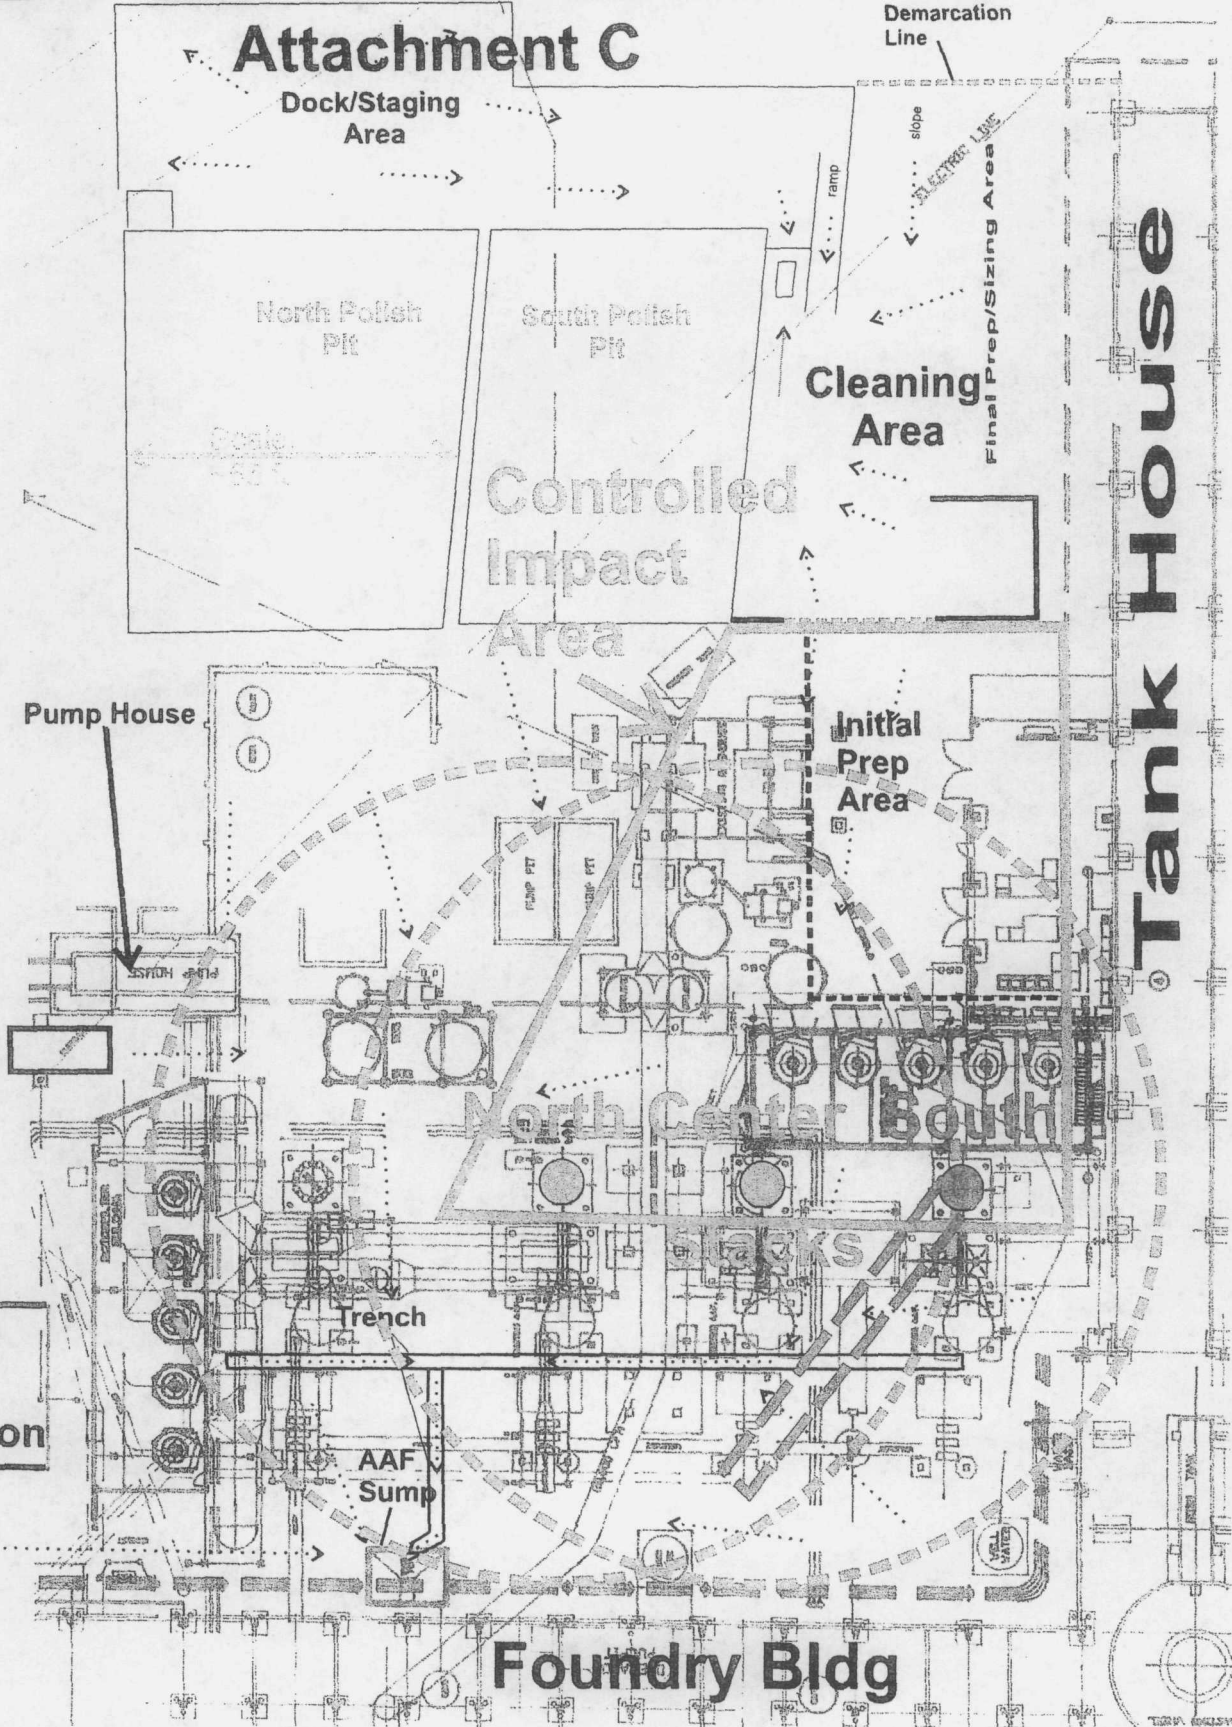
# AAF System Stack Fall Area

11. Within the fall radius of the remaining two stacks (drawing, Attachment C) are two tanks that contain over 5000 gallons of 50% Caustic.
  12. Due to the unsafe conditions in the AAF area, the release by the South Stack has not been cleaned up.

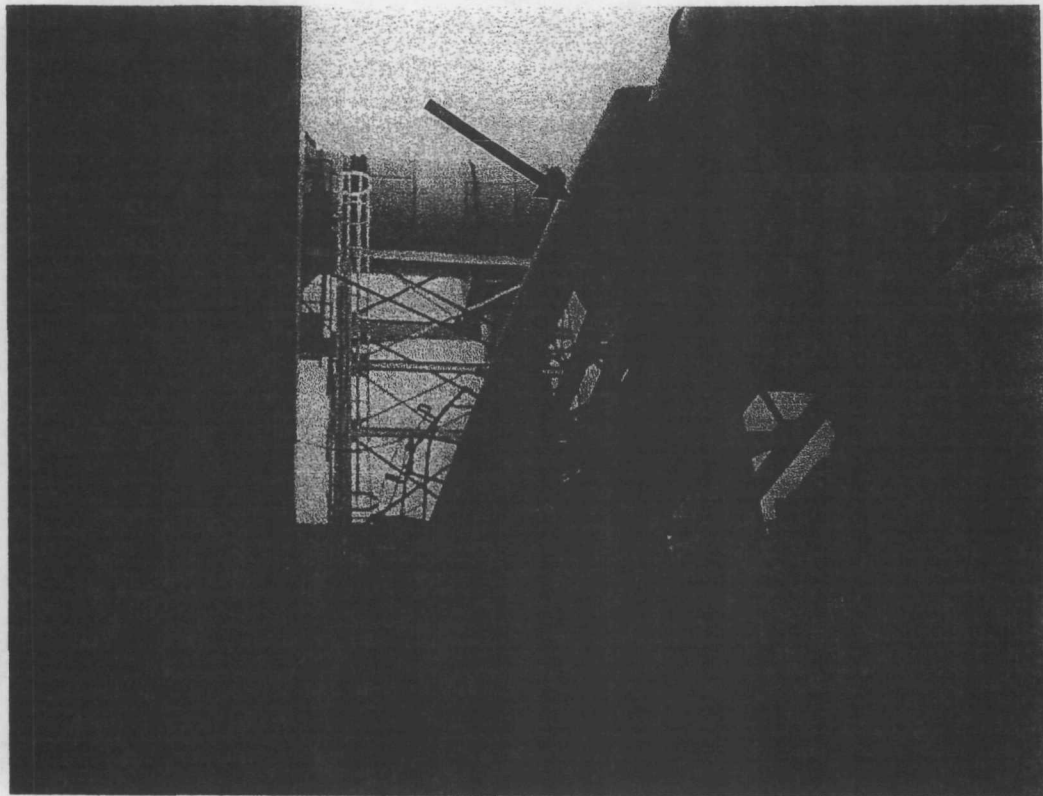
Photo 1 - Looking south at fallen South Stack

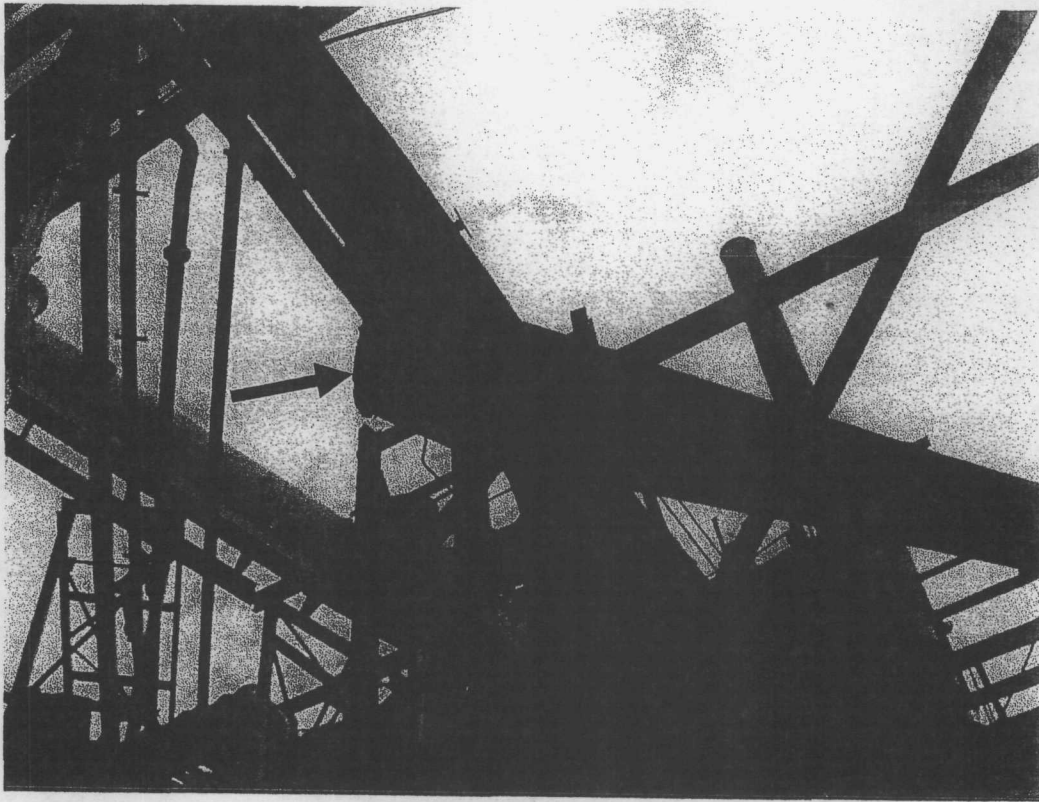
Photo 3 - Looking NE at top of fallen South Stack on top of AAF System duct

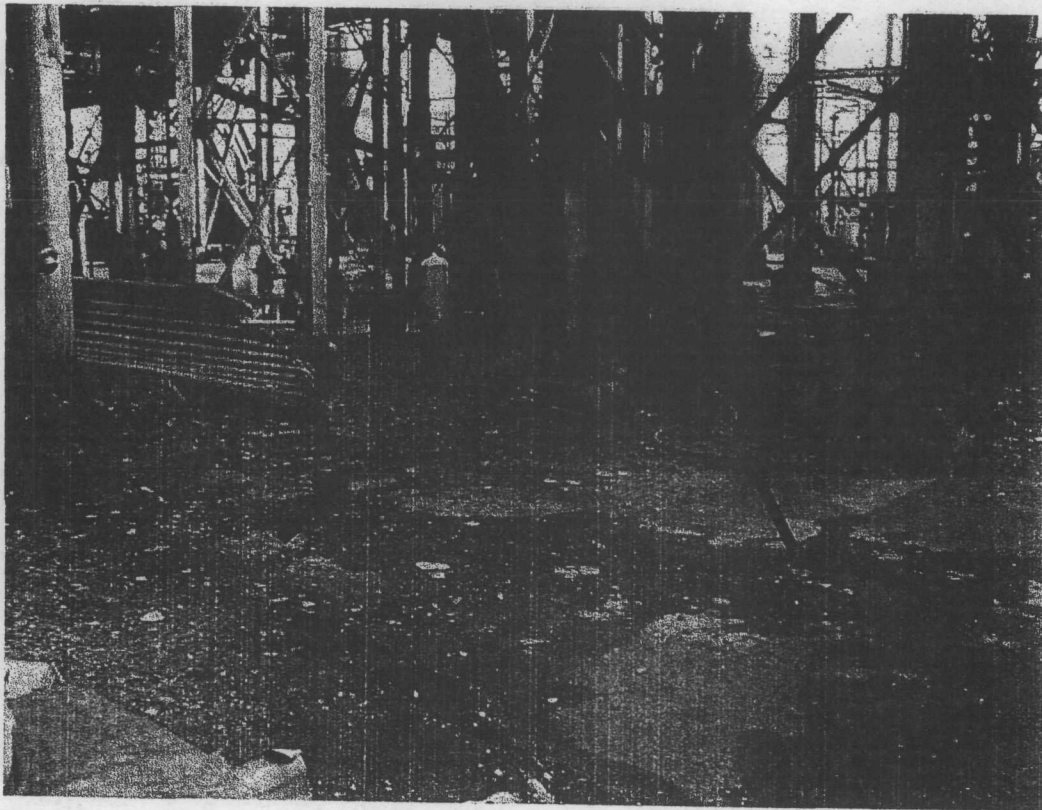
Photo 4 - Scrubber Sludge/Iron Scale debris located below top of fallen South Stack

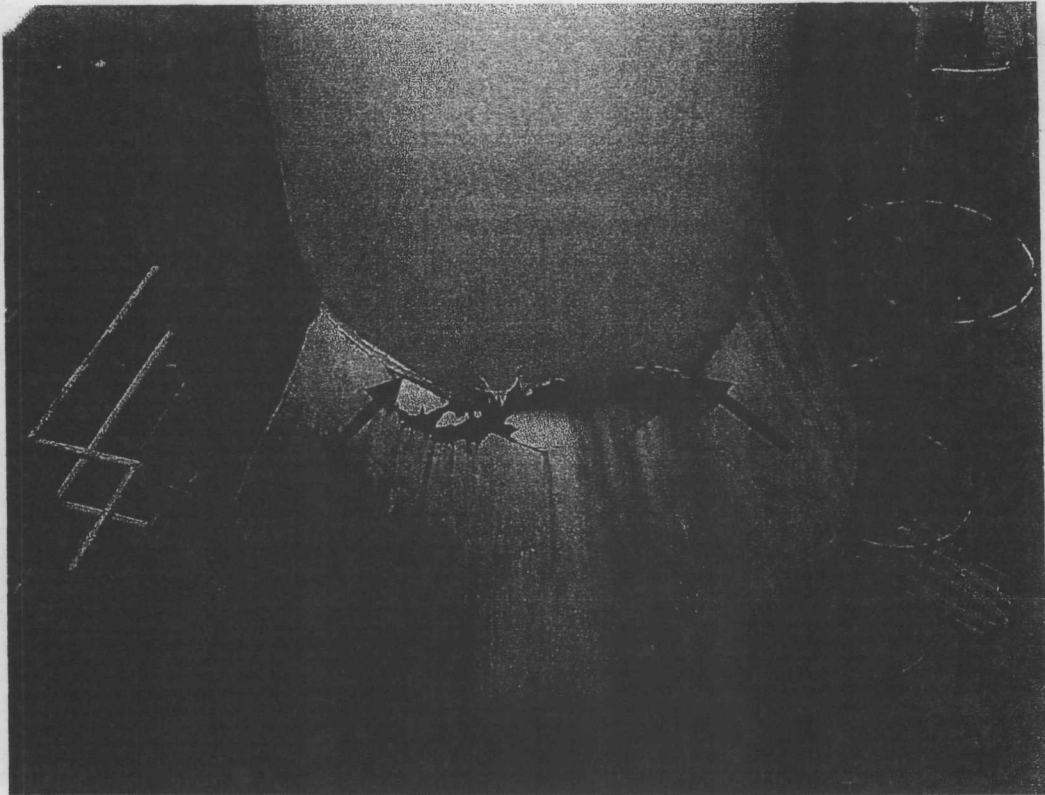
Photo 1 -Looking down from Rotofilter Bldg at South Stack stress failures.

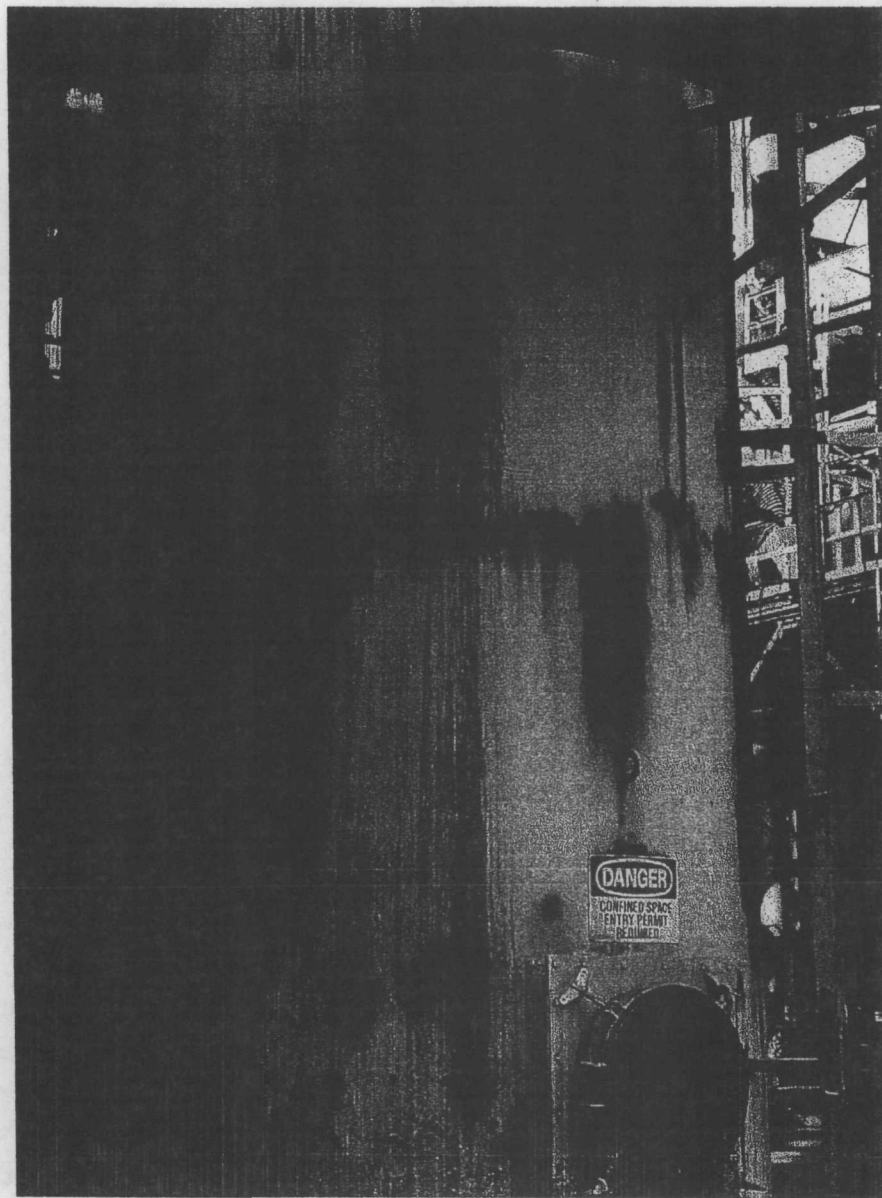
Photo 4 - View of stress and corrosion failures on base of South Stack.

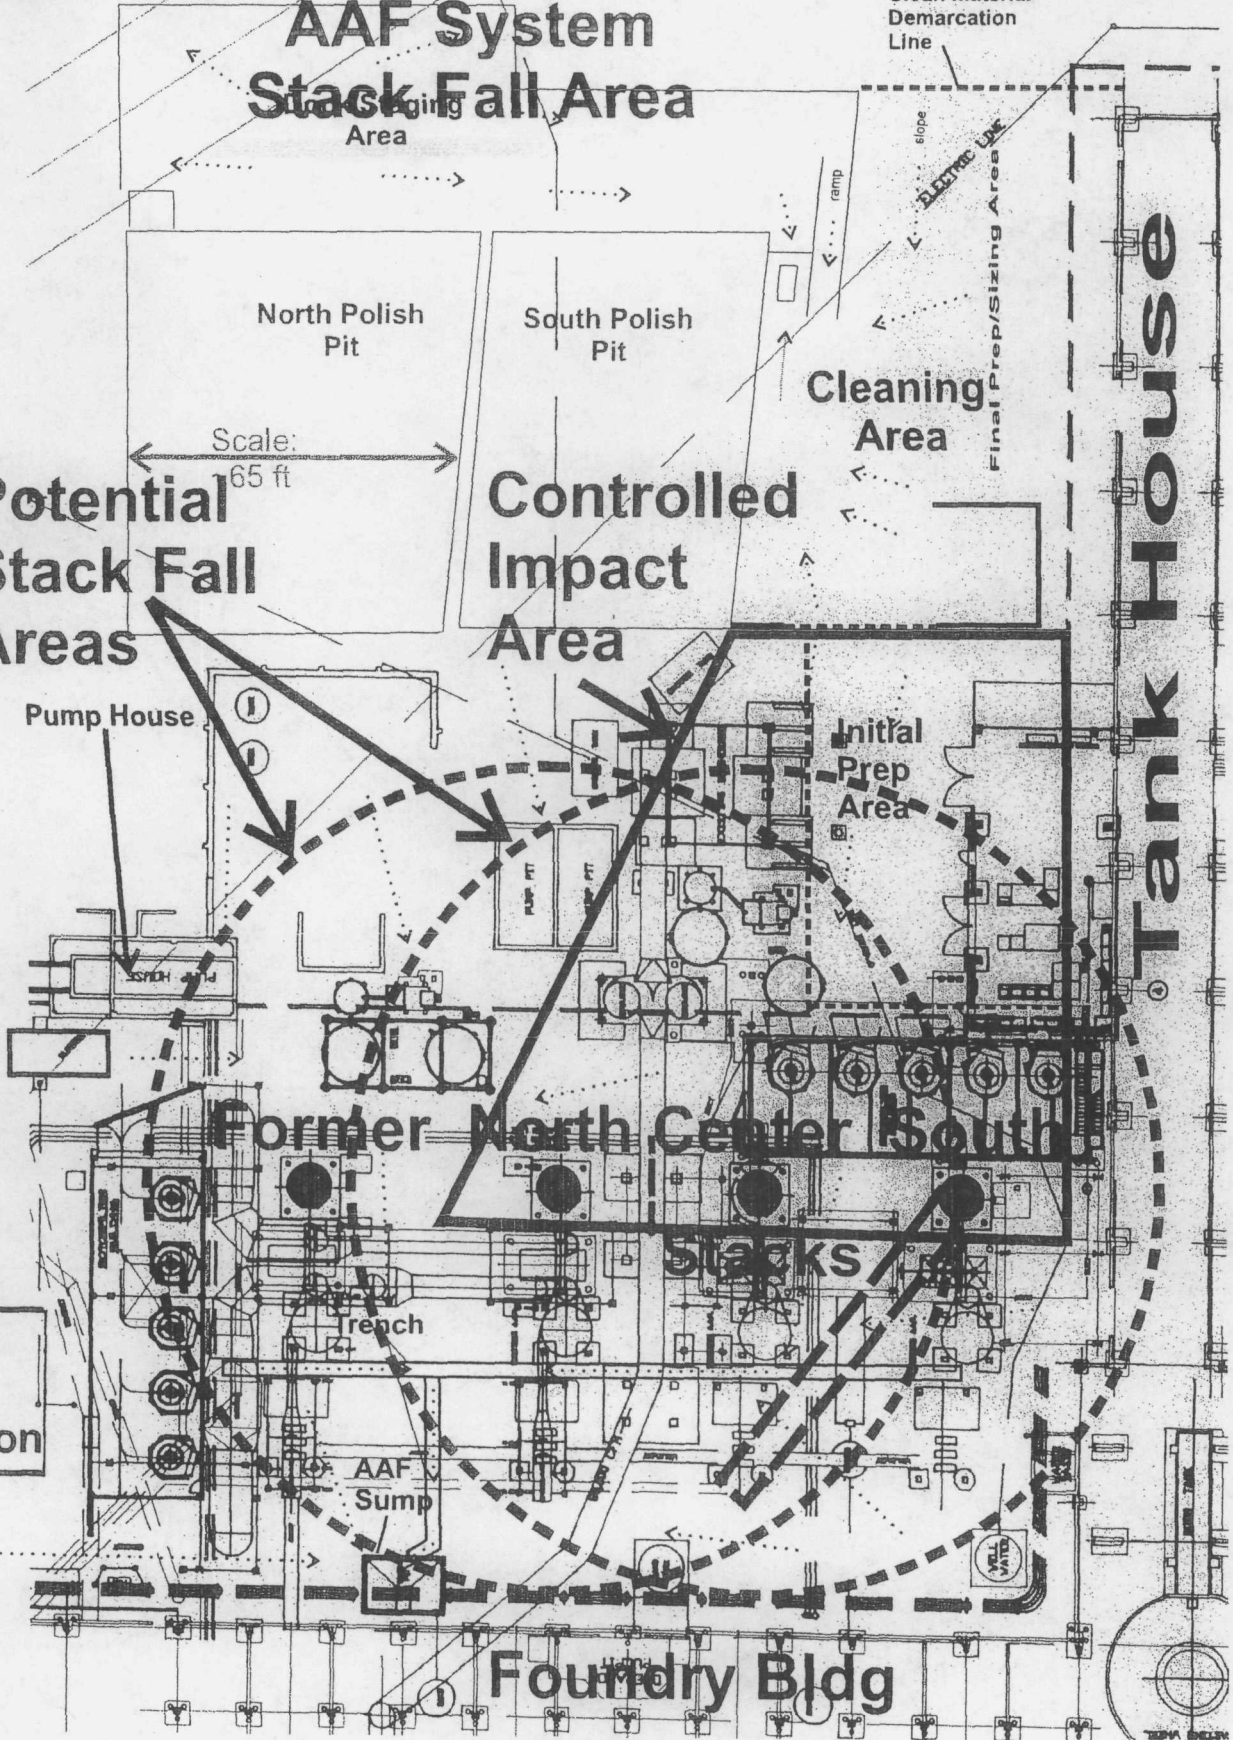
# Attachment C

The do nothing alternative would result in the uncontrolled collapse of the stacks anywhere in the 80 foot radii shown on the AAF System drawing, Attachment B. The timing of the collapse would be unknown. In addition, the impact of falling stacks could severely damage the Foundry and/or Tank House Buildings; the AAF System and potentially release additional scrubber sludge located inside the stacks, system ducts, piping and equipment and also render the system unstable and a major safety concern for future demolition and cleanup by the Estate; damage an electrical substation; and/or damage the site's main pumping station for stormwater control and fire water. Therefore, the Estate does not believe this is an acceptable alternative.
